## Redevelopment Grant Application

Submitted  
by  
City of Mankato  
for  
Sibley Parkway Redevelopment Project

# SIBLEY PARKWAY REDEVELOPMENT PROJECT GRANT APPLICATION

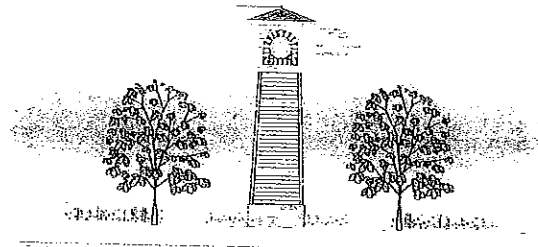
TYPICAL WELCOME CENTER - ENTRANCE ELEVATION  
4'0" x 10'0" x 12'

The home owners will enjoy access to the river with boating, and fishing, a large parks, smaller parks close to home, a trail system connecting to the Village Center providing a unique shopping/entertainment environment. The gateway to this unique environment is set off by a clock tower depicted above.

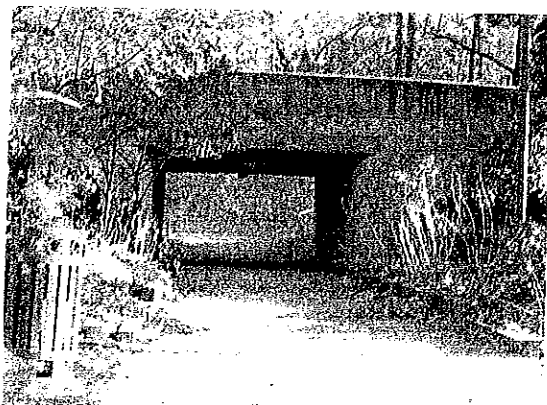
Pedestrian underpasses should be wide well lighted and have wide approaches to them

- Improve the east underpass to accommodate Sibley Parkway;
- Improve the west underpass with architectural treatment, making it more attractive;
- Add a pedestrian underpass at Sibley Street;
- Add a pedestrian underpass at the Mall to accommodate the Regional Trail and improve the access to the office area; and
- Create whistle free crossings at Hubbell and Owatonna Streets

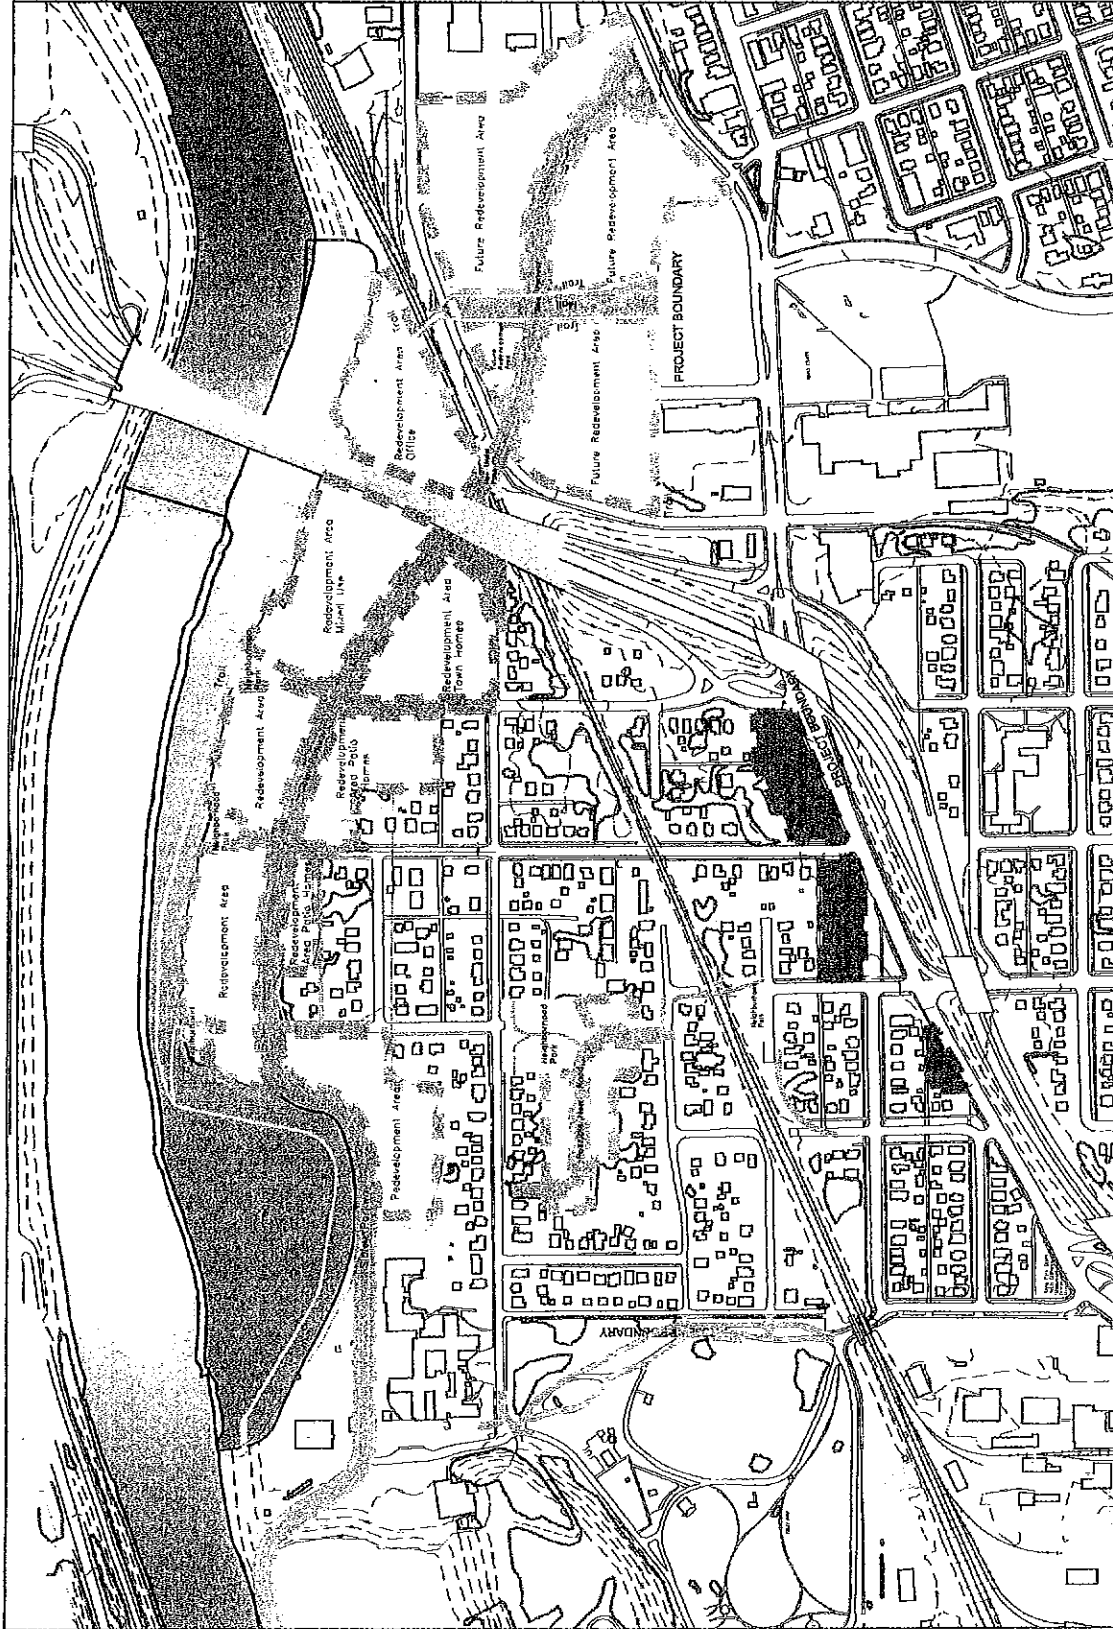
# MAP 2

## SIBLEY PARKWAY REDEVELOPMENT PROJECT

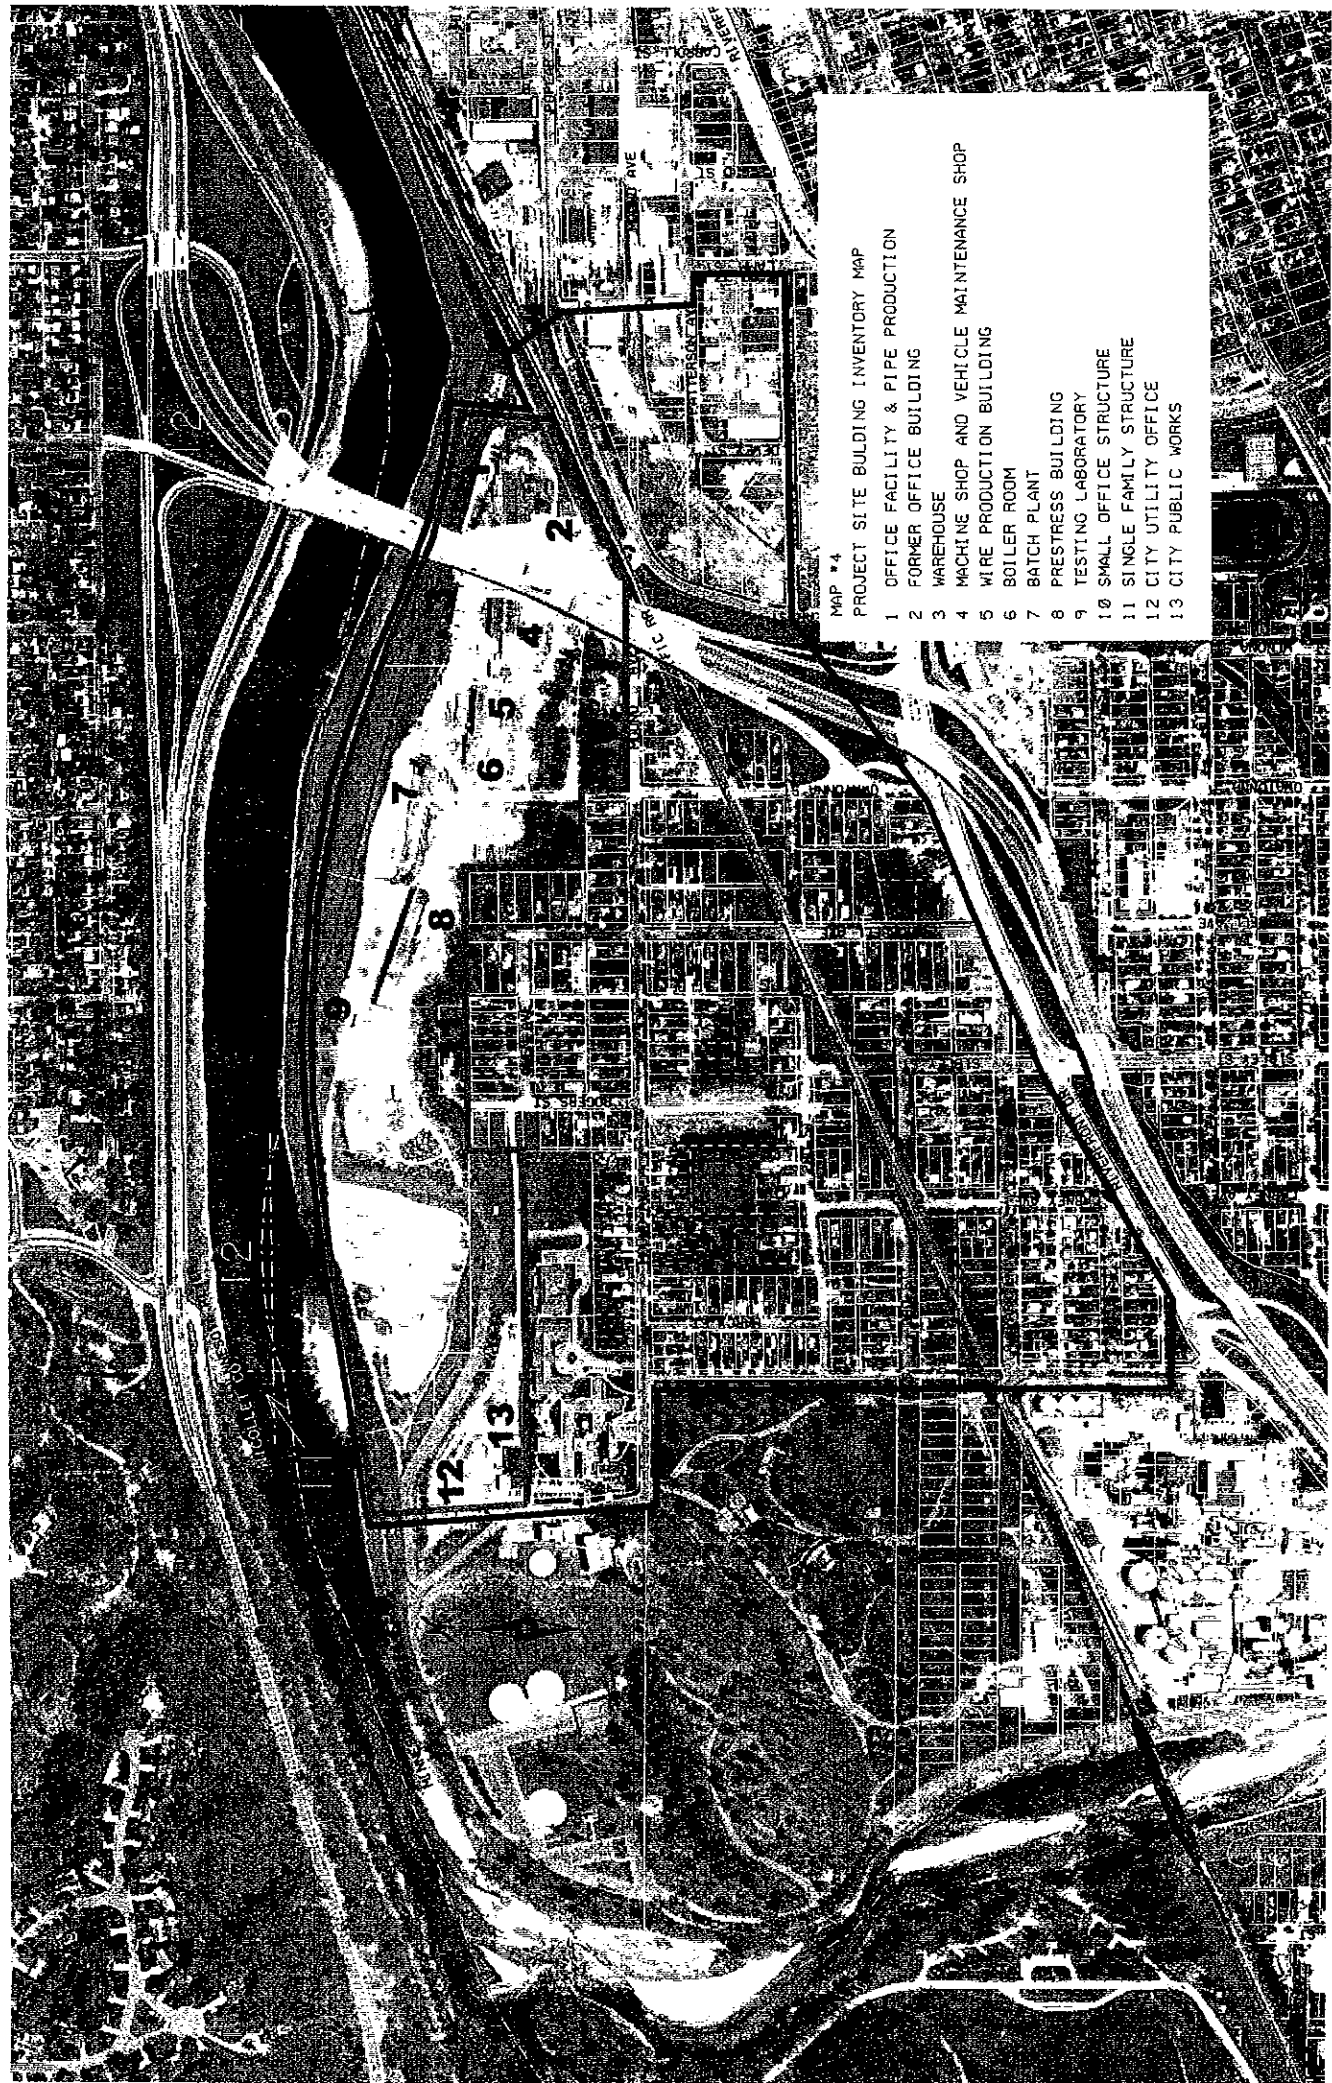
- MAP #4  
PROJECT SITE BUILDING INVENTORY MAP
- 1 OFFICE FACILITY & PIPE PRODUCTION
  - 2 FORMER OFFICE BUILDING
  - 3 WAREHOUSE
  - 4 MACHINE SHOP AND VEHICLE MAINTENANCE SHOP
  - 5 WIRE PRODUCTION BUILDING
  - 6 BOILER ROOM
  - 7 BATCH PLANT
  - 8 PRESTRESS BUILDING
  - 9 TESTING LABORATORY
  - 10 SMALL OFFICE STRUCTURE
  - 11 SINGLE FAMILY STRUCTURE
  - 12 CITY UTILITY OFFICE
  - 13 CITY PUBLIC WORKS

TABLE 4: PROJECT SITE EXISTING BUILDINGS				
PARCEL #	MAP CODE	ACREAGE	NUMBER OF STRUCTURES	CONDITION
R01 08 13 101 045	1	8.78	Vacant Land	NA
R01 08 13 101 046	2	4.90	Vacant Land	NA
R01 08 13 126 005	3	10.31	Buildings #'s 8 & 9	Partially Vacant/ Substandard
R01 08 13 129 023	4	7.36	Building # 7	Vacant/Substandard
R01 08 13 129 024	5	10.54	Buildings #'s 3, 4, 5 & 6	Vacant/Substandard
R01 08 13 129 025	6	2.82	Building # 10	Vacant/Substandard
R01 08 13 202 012	7	7.92	Buildings #'s 1 & 2	Vacant/Substandard
R01 08 14 226 008	8	1.42	Vacant Land	NA
R01 08 13 101 007	9	0.71	Building # 11	Occupied/Substandard
R01 08 13 101 002	10	0.20	Vacant Land	NA
R01 08 13 101 035	11	0.29	Vacant Land	NA
R01 08 13 101 036	12	3.34	Vacant Land	NA
R01 08 14 226 009	13	5.28	Buildings #'s 12 & 13	Occupied/Code Compliant
TOTALS		63.87		
Map Code: Refer to Map #3 "Property Identification Map" for parcel locations				
Refer to Map #4 "Project Site Building Inventory Map" for location of Buildings #'s 1 through 13

As mentioned above, the City-owned property is vacant. Of the remaining nine parcels eight are the site of the former North Star Concrete facilities. North Star Concrete discontinued use of these facilities, for the manufacture of concrete products, in 1998. These buildings are functionally obsolete and for the most part are of substandard condition. Exhibit 6 provides information on each of the 13 buildings remaining on the Project Site. Map #4, "Project Site Building Inventory Map" shows the location of Buildings #'s 1 through 13 on the Project Site.

**Building #1/Map Code #1** -- Office Facility and Pipe Production -- the office structure and pipe production plant are connected together and appear to be of slab-on-grade construction with wood, block, concrete and steel skeletal construction, depending on location. The structure appears to have been constructed in many different phases as the operation expanded. A portion of the office structure has a second floor. The office structure appears to be heated with forced air furnaces, fired with natural gas and powered by electricity. Roof mounted cooling units were observed. The pipe production area appears to be heated by ceiling or wall-mounted, natural gas fired, electrical powered furnaces. The kilns appear to be heated by a natural gas powered boiler which supplied steam to the curing kilns. These facilities are vacant. Deficiencies identified include:

**Building #2/Map Code #2** -- Former Office Building -- referred to as the "White House", likely because of its white exterior. The floor of the facility appears to be constructed at a height of 3 to 4 feet above the exterior ground level. The floor appears to be constructed of concrete, with precast panel walls and roof. The interior has been finished with common interior construction products. Deficiencies identified include:

**Building #3/Map Code #3 -- Warehouse --** this warehouse structure is comprised of two structures. Both of these structures appear to have their floors constructed at 2 to 3 feet above the exterior grade. The floors are of concrete construction; the eastern half is wood framed with steel siding. The western half is constructed of cement masonry units with steel joists. The roof is flat and appears to have been constructed by placing a steel mesh across the joists and casting a concrete material on top of the mesh. No heating or cooling equipment was observed within this structure. Deficiencies identified include:

**Building #5/Map Code #5 -- Wire Production Building --** this steel frame building has a floor slab constructed on grade. The south, east and west walls are open to the environment. The north wall and the roof are enclosed using precast concrete panels. No heating or cooling systems were observed. Deficiencies identified include:

**Building #6/Map Code #6 -- Boiler Room** -- this building is slab-on-grade with block walls and steel joist roof support covered by steel mesh and concrete. A room on the eastern portion has a roof of precast concrete panels. Two gas fired, fuel oil back-up boilers were observed within the structure. Deficiencies identified include:

**Building #7/Map Code #7 -- Batch Plant** -- batch plant is constructed of a steel beam skeleton with block, concrete or precast concrete panels. A basement area was observed which provided access to a service tunnel which connects to Building #6 (Boiler Room) to access steam and/or hot water. This facility is heated by gas fired, electrically powered furnaces and hot water radiant heat, depending on location. A conveyor belt structure extends from the batch plant to the west. Deficiencies identified include:

**Building #8/Map Code #8 -- Prestress Building** -- this building is a slab-on-grade structure of steel-frame and precast concrete construction. A large natural gas fired, electrically powered furnace was observed nearer the west end. Steam is supplied to the structure for concrete curing purposes via a service tunnel that connects to Building #7 and subsequently to Building #6 (Boiler Room). Deficiencies identified include:

**Building #9/Map Code #9 -- Testing Laboratory** -- this structure is slab-on-grade construction with cement masonry unit walls and a roof made of prestressed concrete panels or steel joists covered with a steel grate covered with concrete. A natural gas fired, electrically powered forced air furnace was observed within the building. A natural gas fired boiler was observed on the southeast corner of the building. The boiler is connected to Buildings #7 and #8 via a service tunnel. A well head for on-site well is also located near the boiler and supplies water to much of the facility for industrial uses. Deficiencies identified include:

**Building #10/Map Code #10** -- Small Office Structure -- this wood-frame structure is slab-on-grade. Deficiencies identified include:
